## **Thermal Insulation and Heat Loss Assessment**

**Property Address:** xxxxxxxxxxx, x, Ohio xxx

**Report Number:** 090127c

**Date:** January 27, 2009

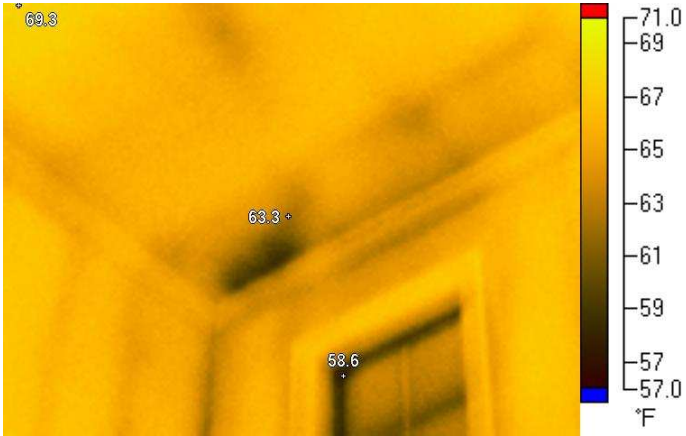
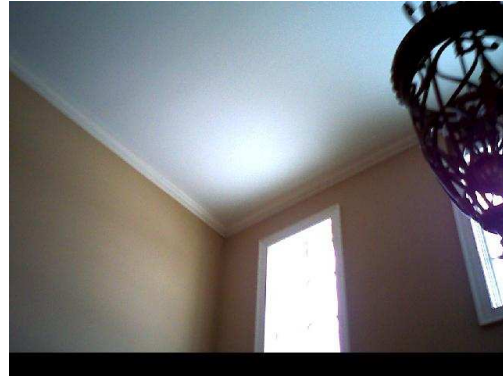
**IR000587.IS2**

**Ceiling in entry way.**  
Temperature not terrible but insulation may be disturbed or not completely in place.

Recommend evaluation for additional insulation or redistribution of insulation in areas shown in pictures below.

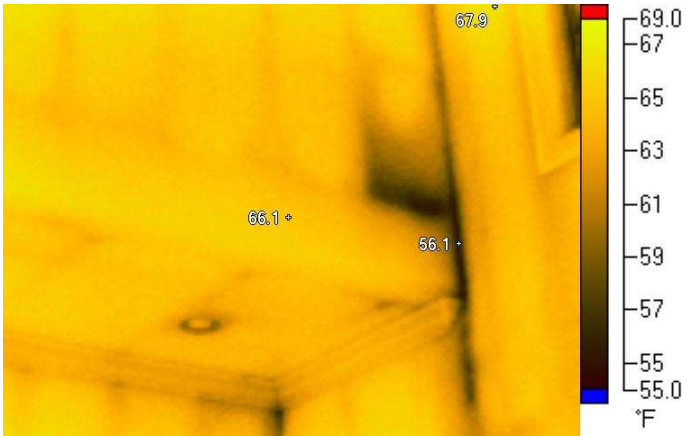
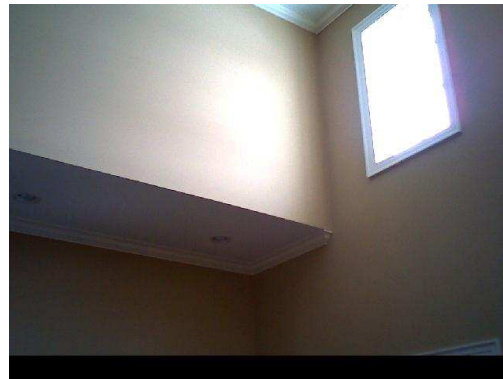
**IR000589.IS2**

**Side wall in entry way. 59.8 degrees in the dark area.**

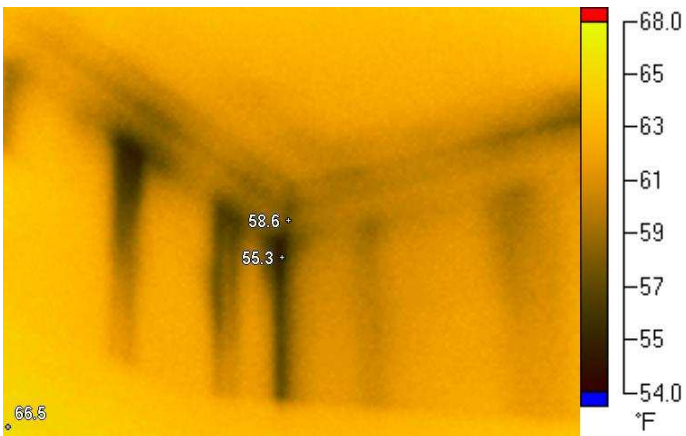
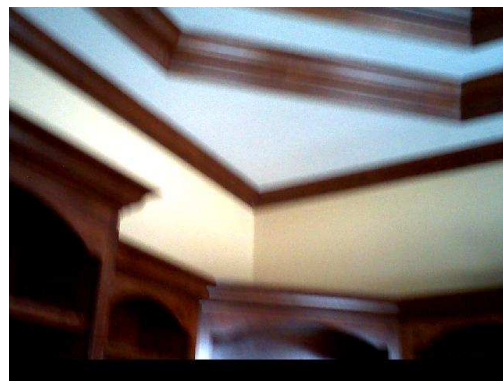
**IR000590.IS2**

**Office over cabinets**

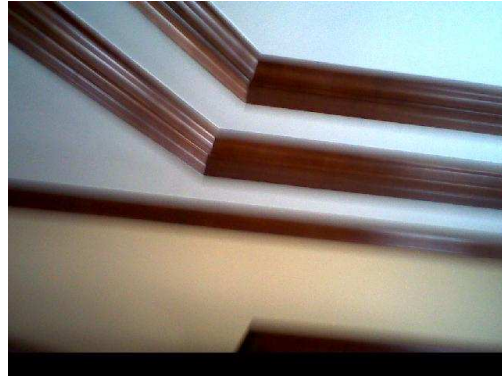
**IR000591.IS2**  
1/27/2009 2:14:27 PM

**Lower tier of soffit on left outside wall from office entry view.**

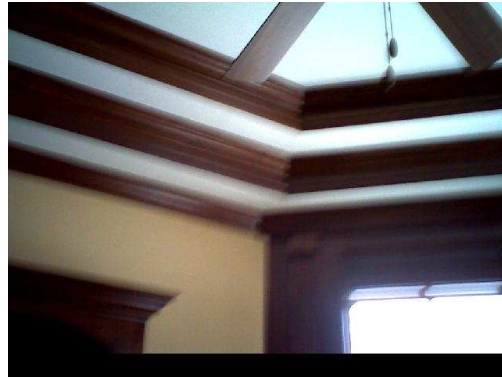
**IR000592.IS2**  
1/27/2009 2:14:44 PM

**Soffit area main office left of window toward the front.**

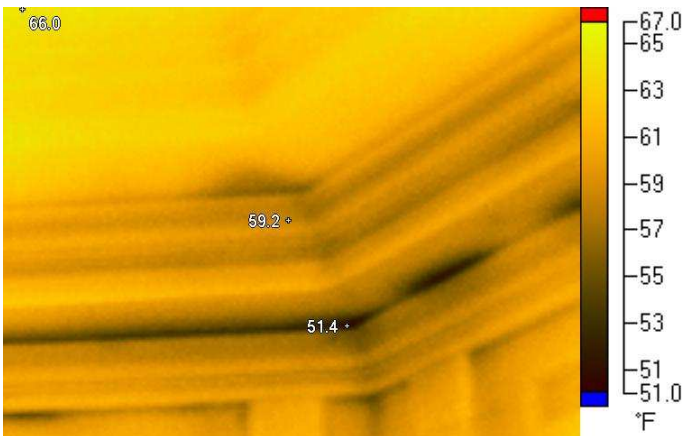
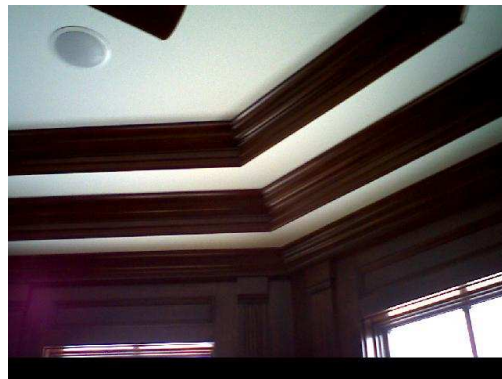
**IR000593.IS2**  
1/27/2009 2:15:07 PM

**Soffit area main office over windows. Lower tier.**

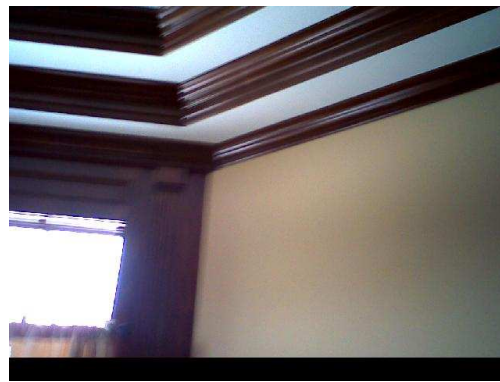
**IR000594.IS2**

**Main office right wall from entry door view.**

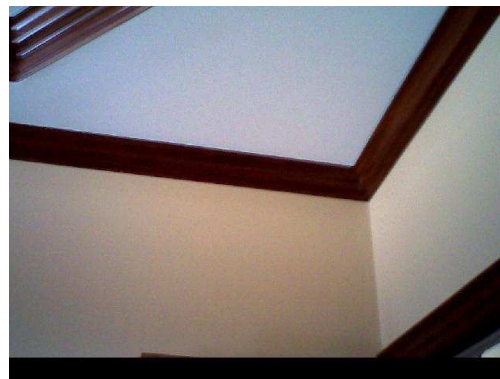
**IR000595.IS2**

**Main office looking back at entry door. Wall to the right over cabinets. Not terrible but evidence of possible air infiltration**

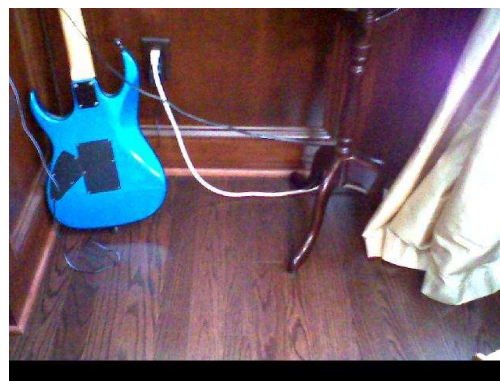
**IR000596.IS2**

**Main corner front left corner at the baseboard.**

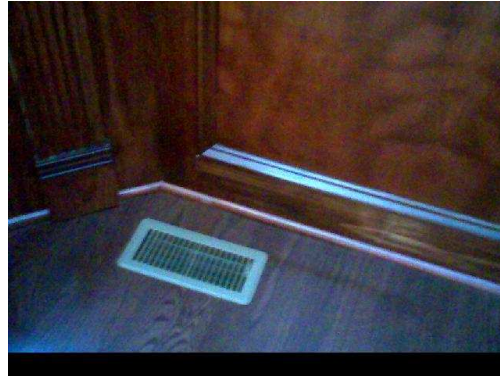
**IR000597.IS2**  
1/27/2009 2:19:10 PM

**Main office front right corner at the baseboard.**

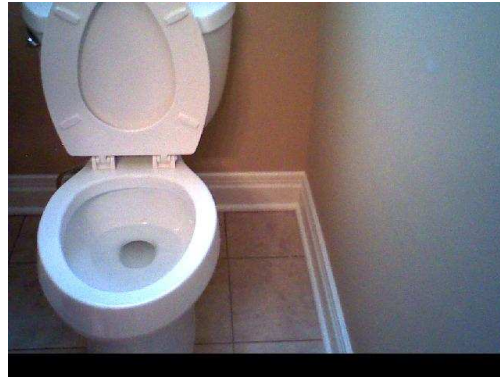
**IR000598.IS2**  
1/27/2009 2:21:10 PM

**Guess bathroom first floor right of toilet.**

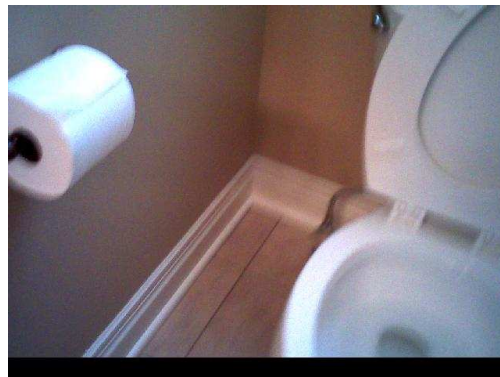
**IR000599.IS2**  
1/27/2009 2:21:24 PM

**Guess bathroom first floor left of toilet.**

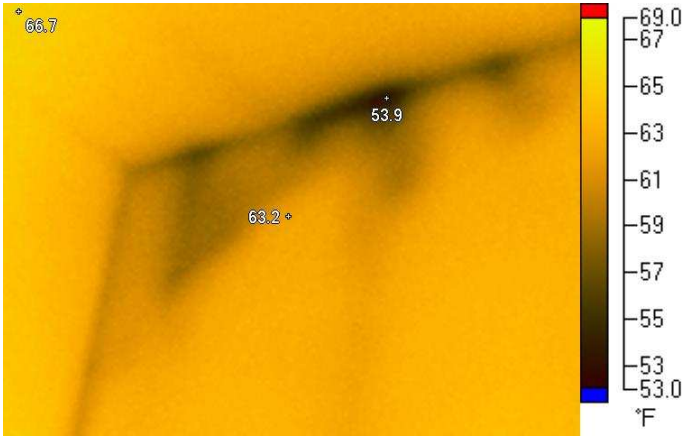
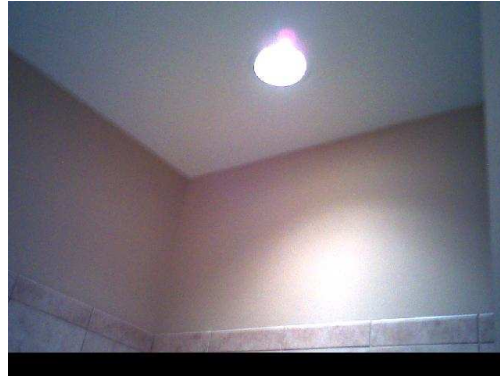
**IR000600.IS2**

**Guess bathroom over shower.**

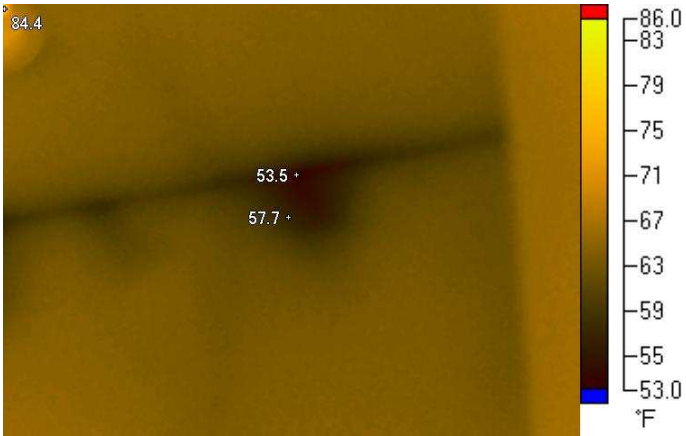
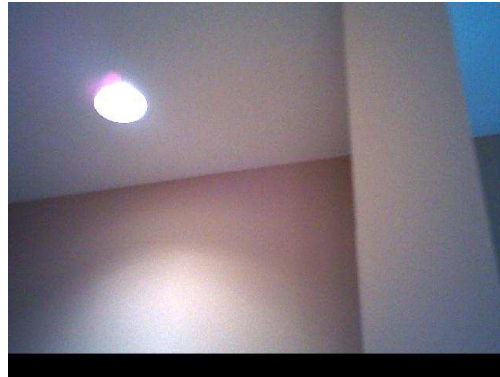
**IR000601.IS2**

**Guess bathroom over shower.**

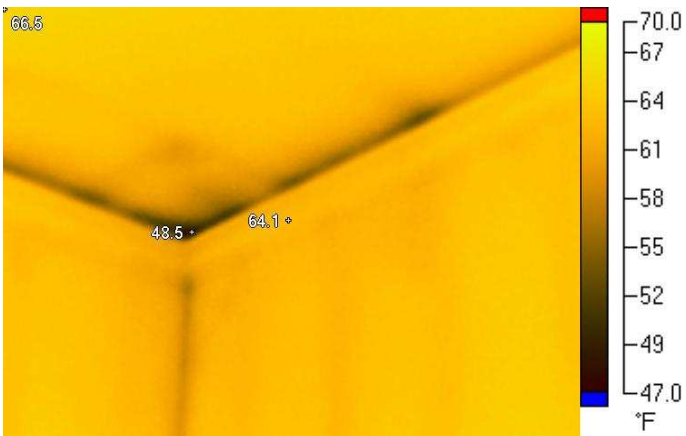
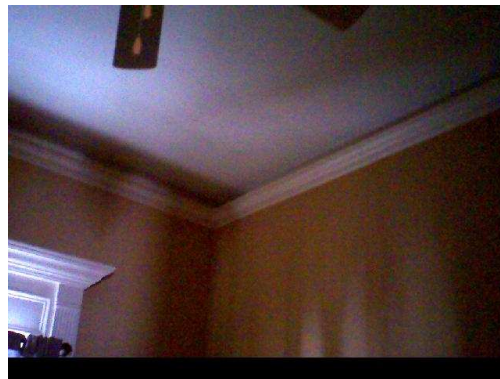
**IR000602.IS2**

**Guess bedroom rear ceiling at corner.**

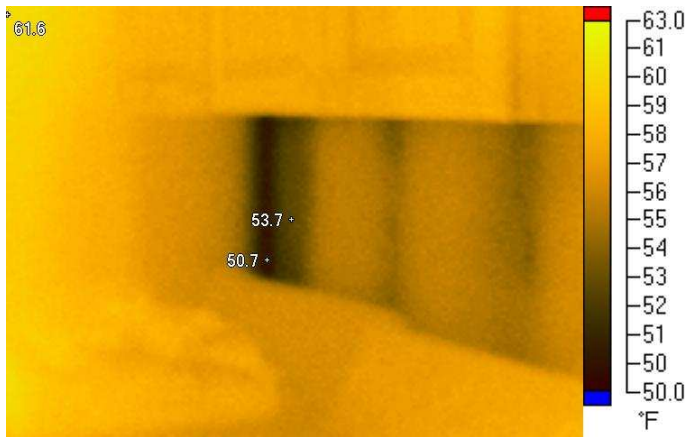
**IR000612.IS2**  
1/27/2009 2:53:20 PM

**Laundry room corner next to dryer.**
