i-TECH
ENERGY SERVICES

Thermal Insulation and Heat Loss Assessment

Report Number: 090127c

Date: January 27, 2009

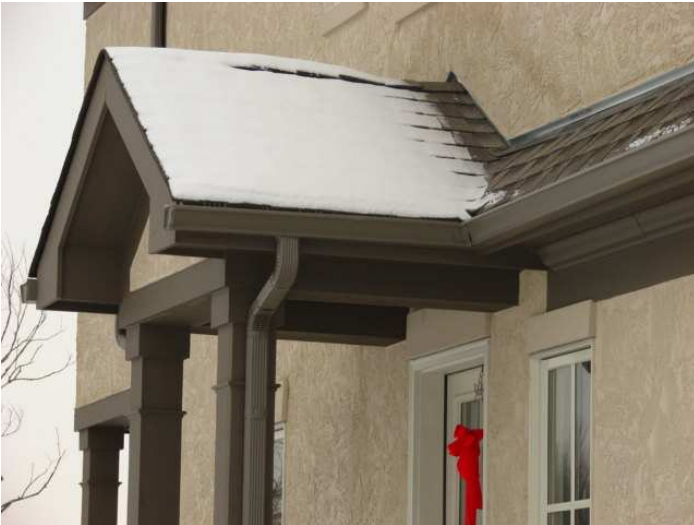
Visual inspection of dormer/porch cover over side entrance found soffit vents at the area attached to the structure. The soffit vents are needed but this area should be sealed from the structure. Due to the cold areas inside that coincide with this dormer/cover, this area may not be sealed and allowing air to infiltrate the structure. To be certain intrusive investigation would be needed. The cold areas are the 1st floor laundry room, hall bath, and bedroom above.

Dormer/porch cover on side of house

Recommend evaluation of dormer over the side entrance to verify a seal between the house and the dormer/porch cover.

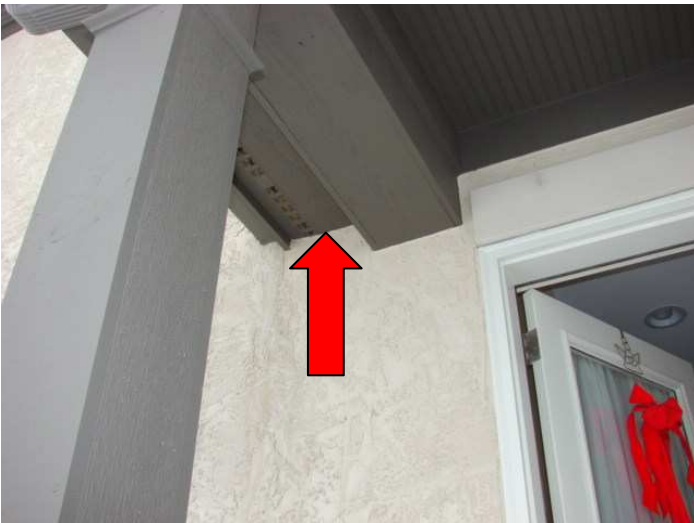
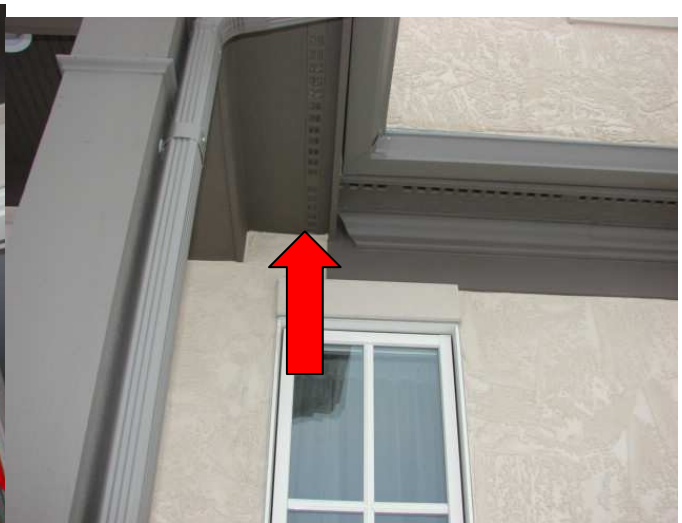
Areas of concern at dormer/porch cover soffit vents

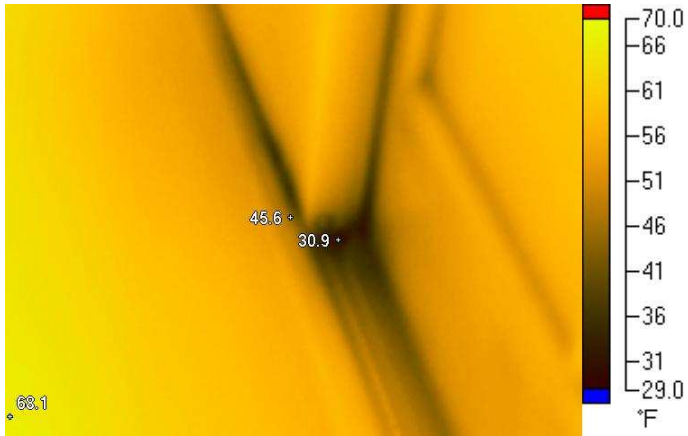
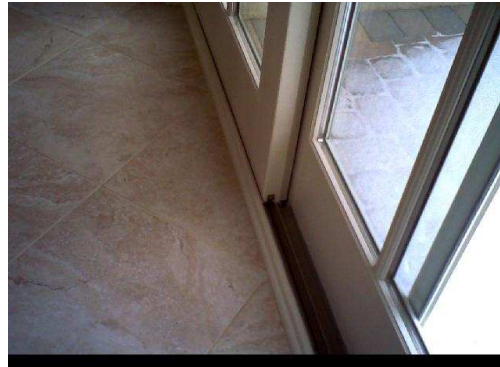
IR000584.IS2

Thermal imaging indicates cold air infiltration at bottom center of sliding door on left side of eating area.

Sliding door on left side of eating area.

Suggest repair of weather stripping on bottom of sliding glass door on left side of eating area.

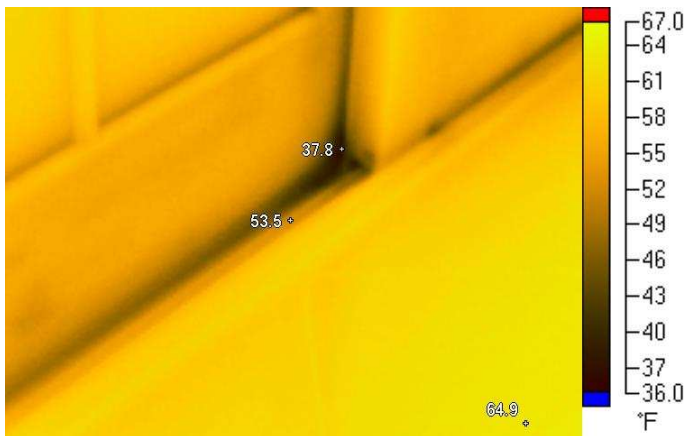
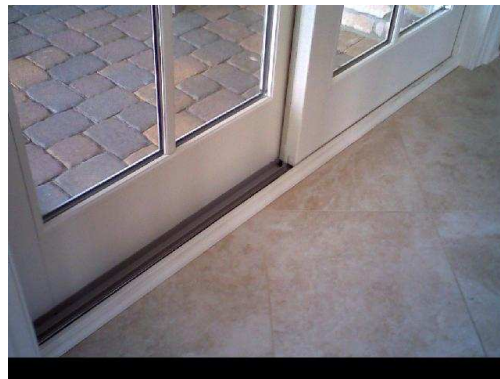
IR000585.IS2

Sliding door on right side of eating area to porch.

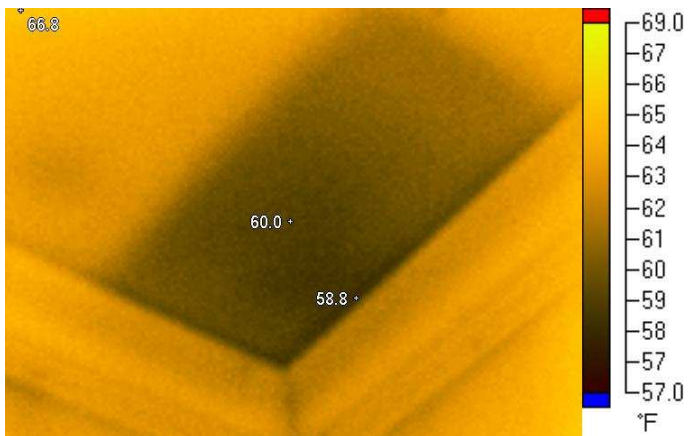
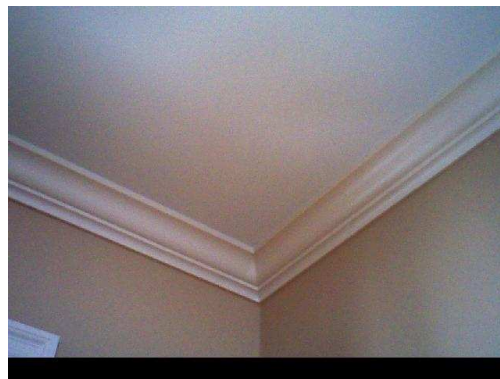
IR000586.IS2

Soffit in front right corner of main dining room.

Recommend evaluation for additional insulation or redistribution of insulation in areas shown in pictures below.

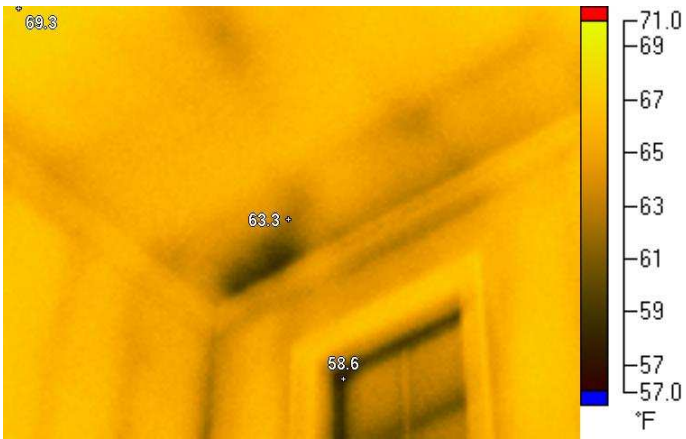
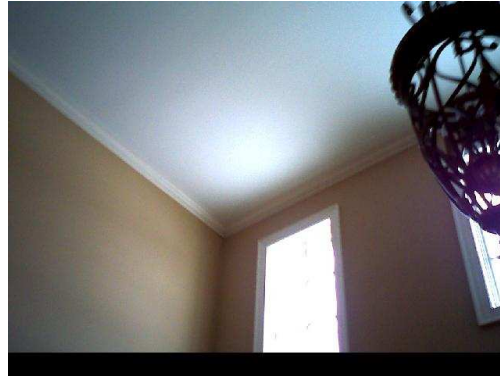
IR000587.IS2
1/27/2009 2:10:05 PM

Ceiling in entry way. Insulation may be disturbed or not completely in place.

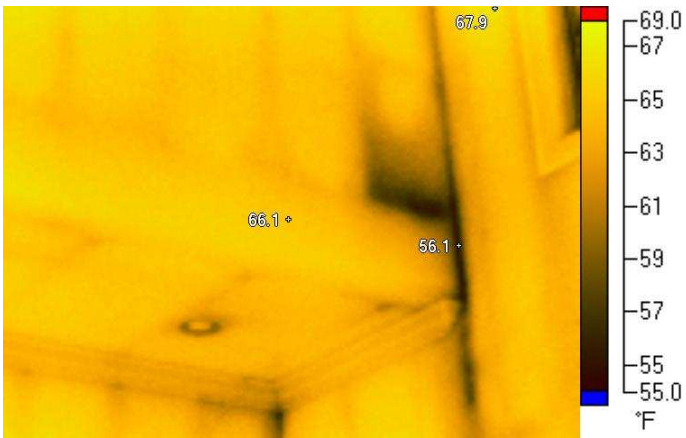
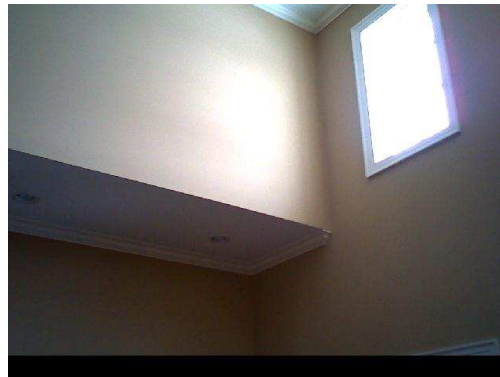
IR000589.IS2
1/27/2009 2:11:04 PM

Side wall in entry way. 59.8 degrees in the dark area.

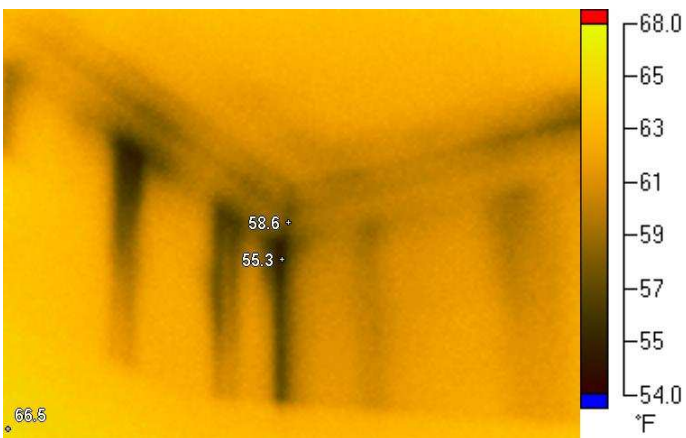
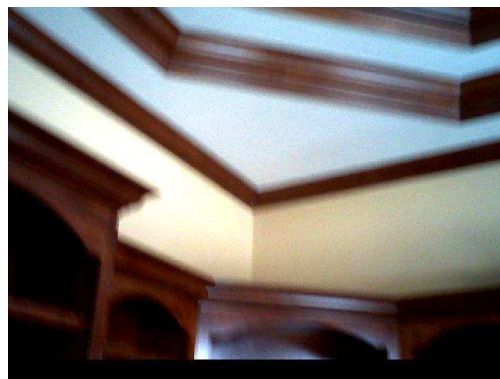
IR000590.IS2
1/27/2009 2:13:28 PM

Office over cabinets

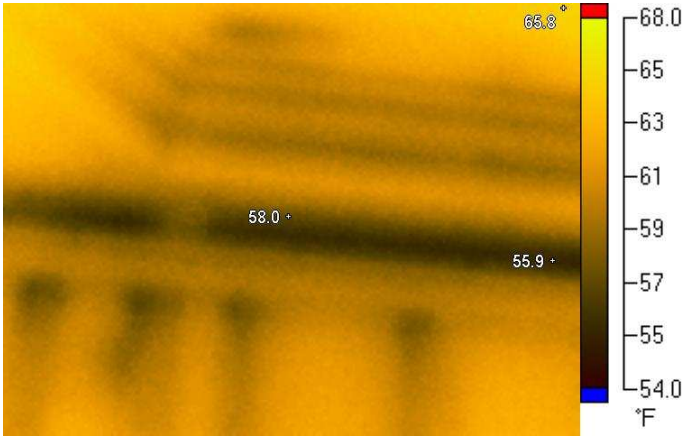
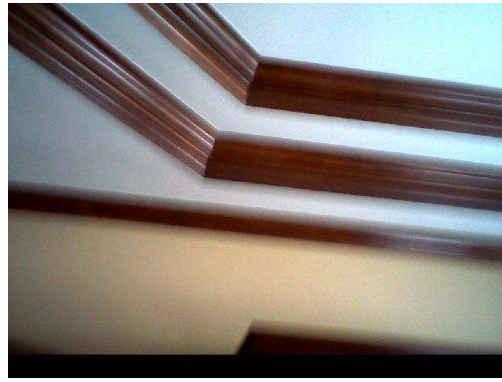
IR000591.IS2
1/27/2009 2:14:27 PM

Lower tier of soffit on left outside wall from office entry view.

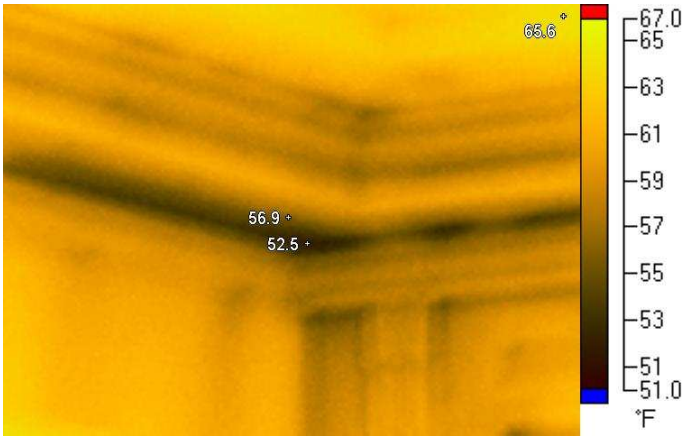
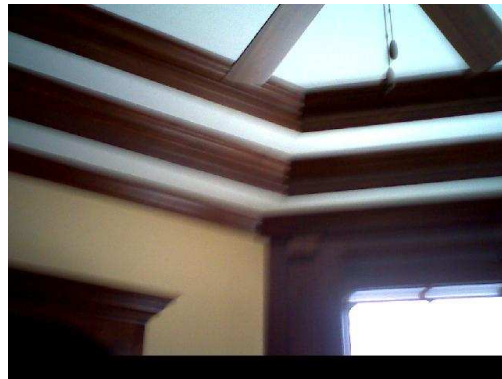
IR000592.IS2
1/27/2009 2:14:44 PM

Soffit area main office left of window toward the front.

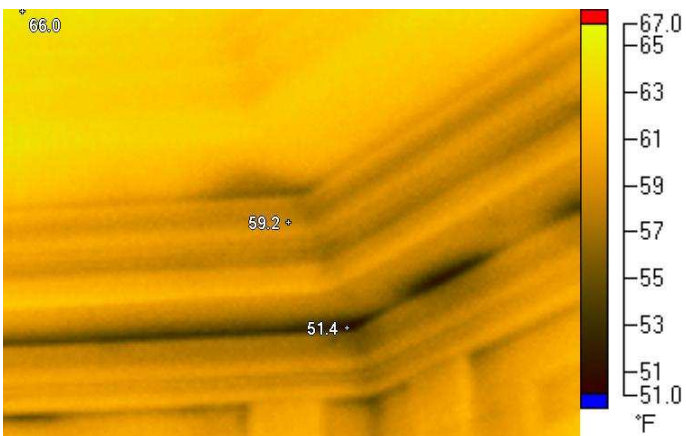
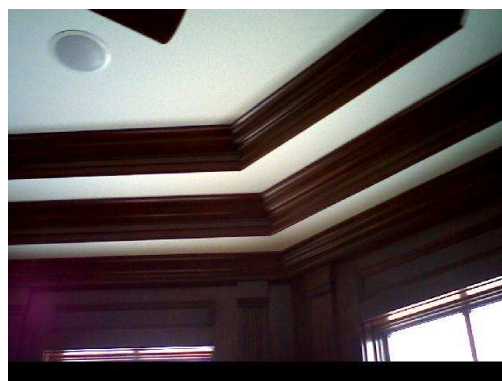
IR000593.IS2
1/27/2009 2:15:07 PM

Soffit area main office over windows. Lower tier.

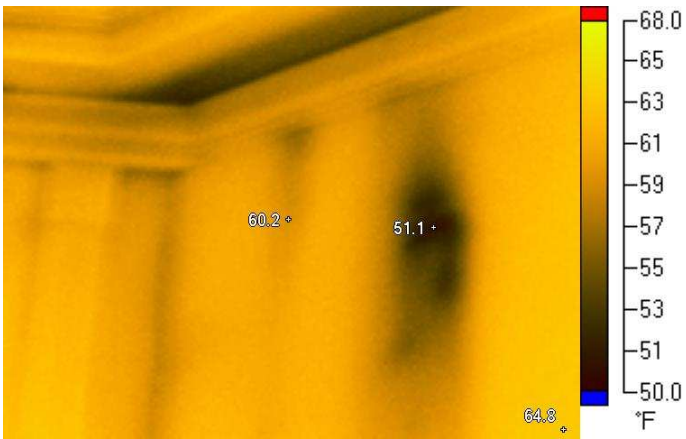
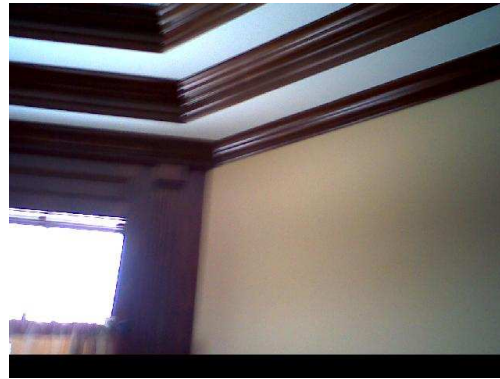
IR000594.IS2

Main office right wall from entry door view.

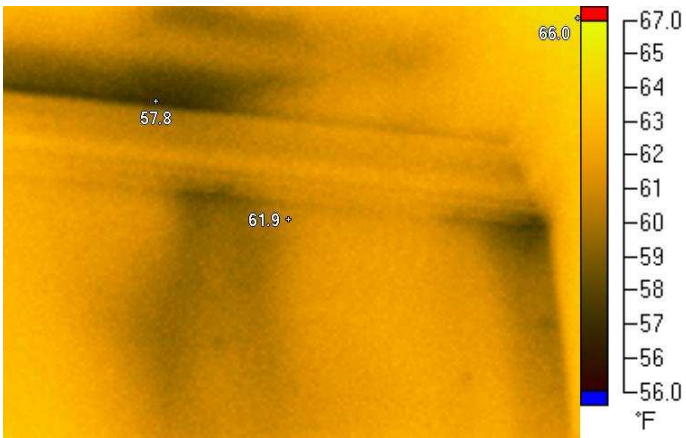
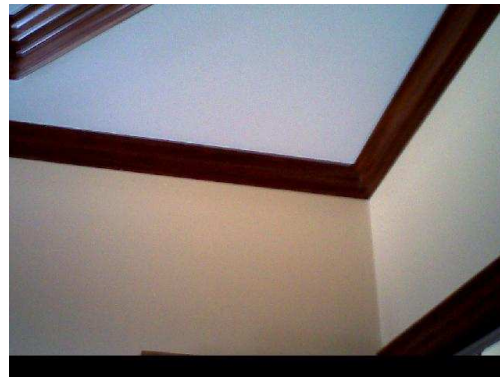
IR000595.IS2

Main office looking back at entry door. Wall to the right over cabinets. Evidence of possible air infiltration or disturbed insulation.

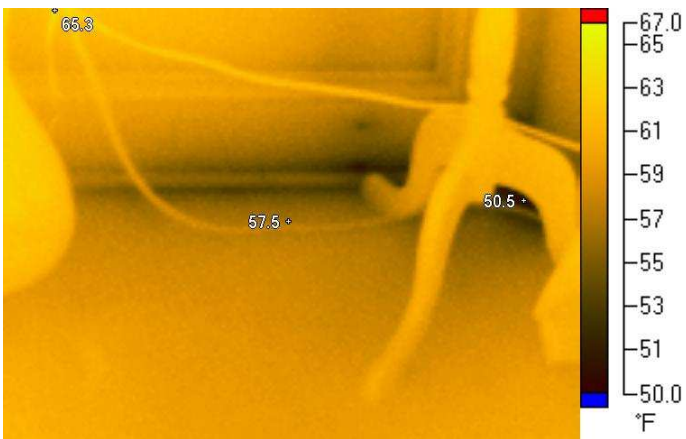
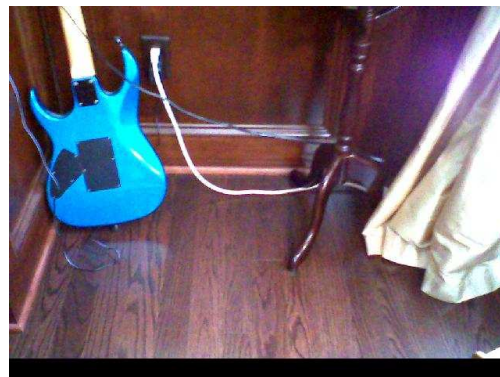
IR000596.IS2

Main corner front left corner at the baseboard.

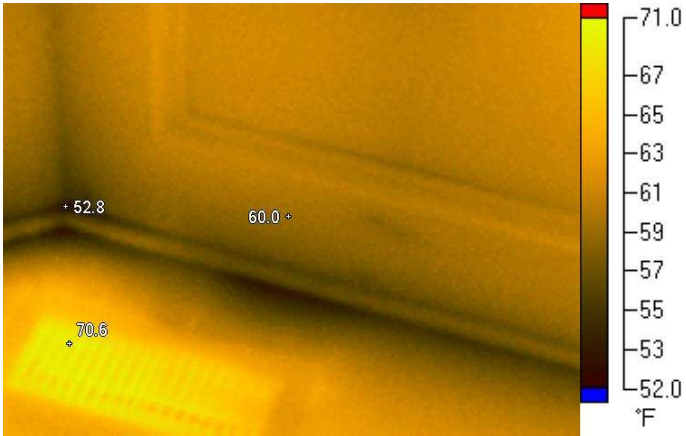
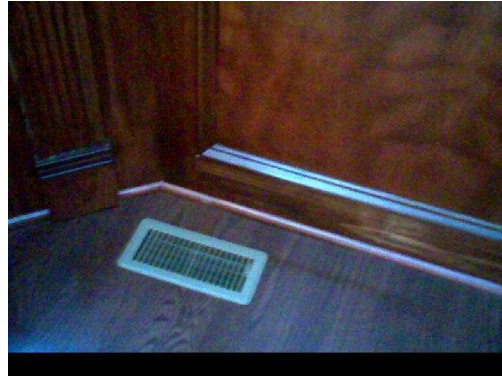
IR000597.IS2

Main office front right corner at the baseboard.

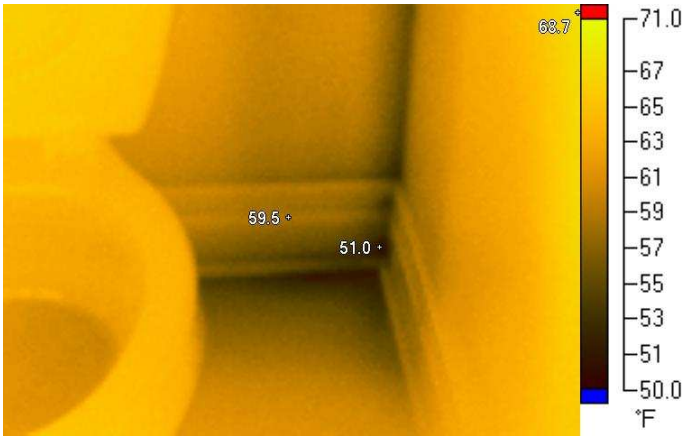
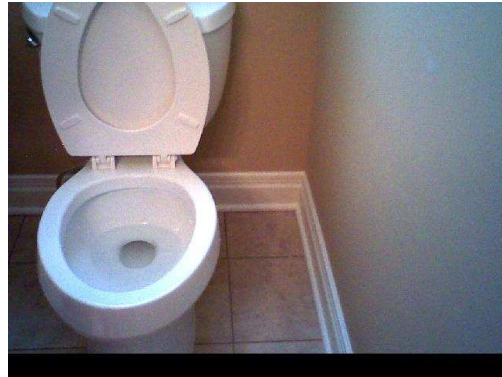
IR000598.IS2

Guest bathroom first floor right of toilet.

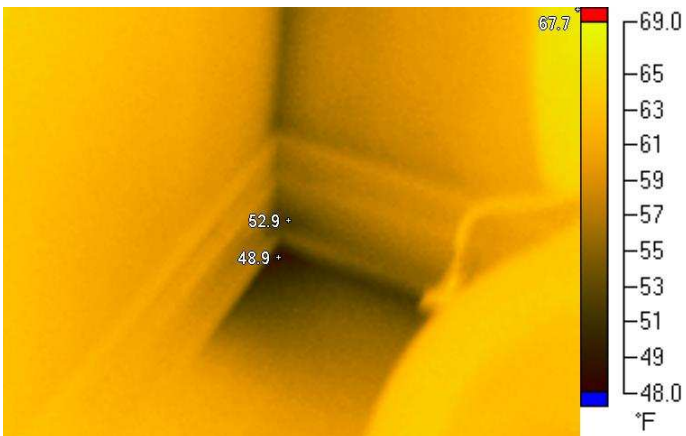
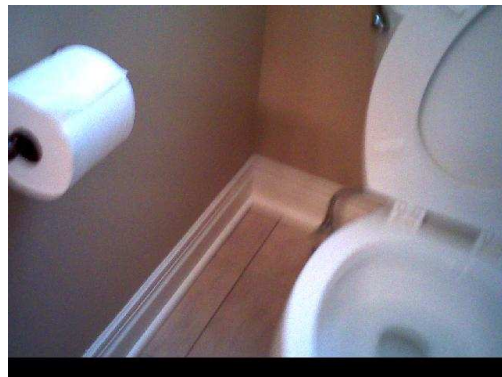
IR000599.IS2

Guest bathroom first floor left of toilet.

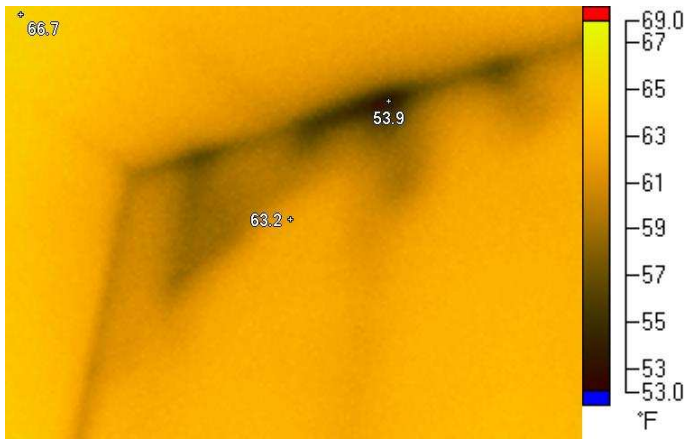
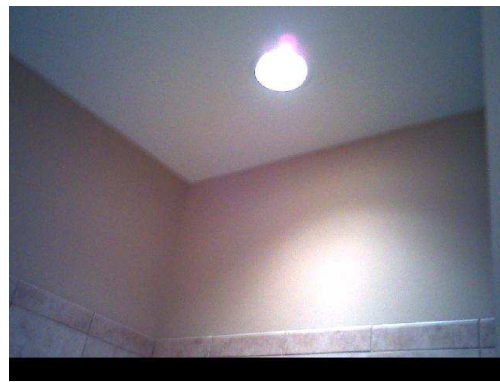
IR000600.IS2
1/27/2009 2:21:57 PM

Guest bathroom over shower.

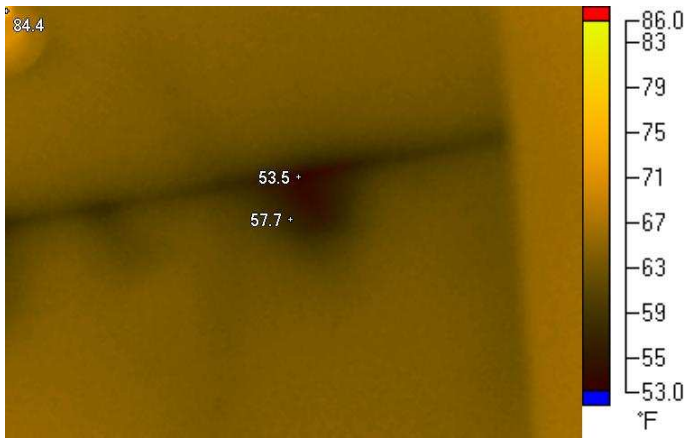
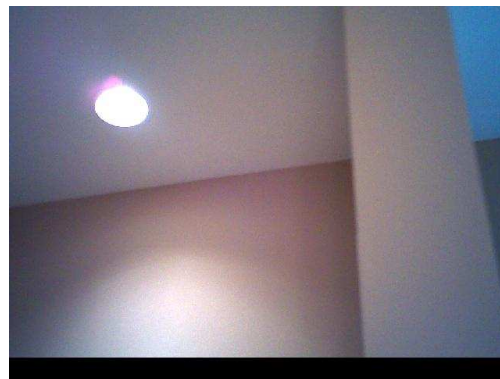
IR000601.IS2
1/27/2009 2:22:45 PM

Guest bathroom over shower.

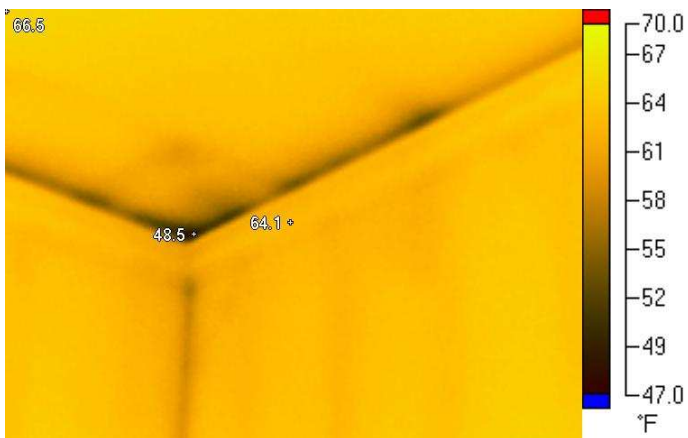
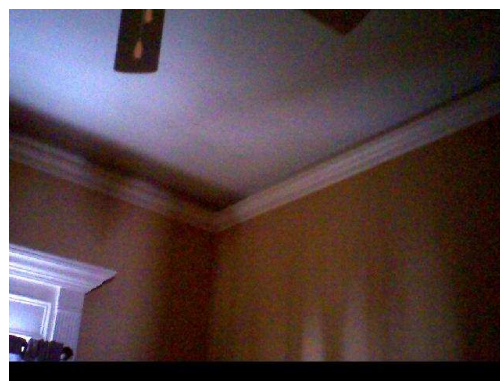
IR000602.IS2
1/27/2009 2:23:55 PM

Guest bedroom rear ceiling at corner.

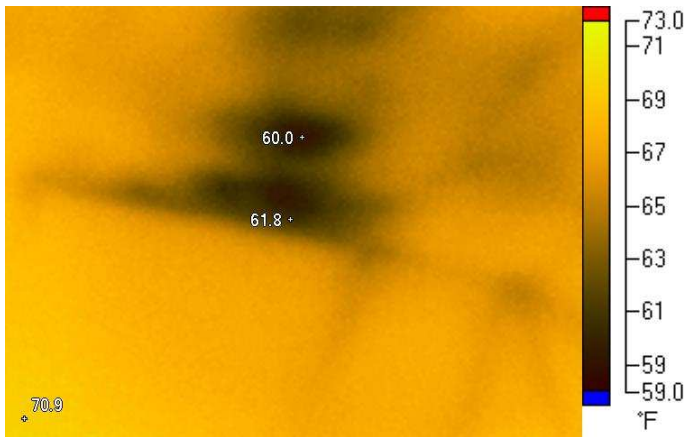
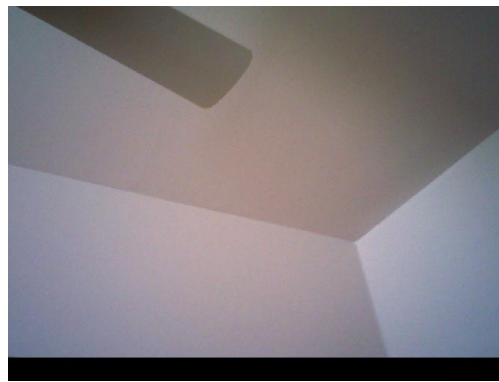
IR000603.IS2

Master bedroom ceiling right side of bed.

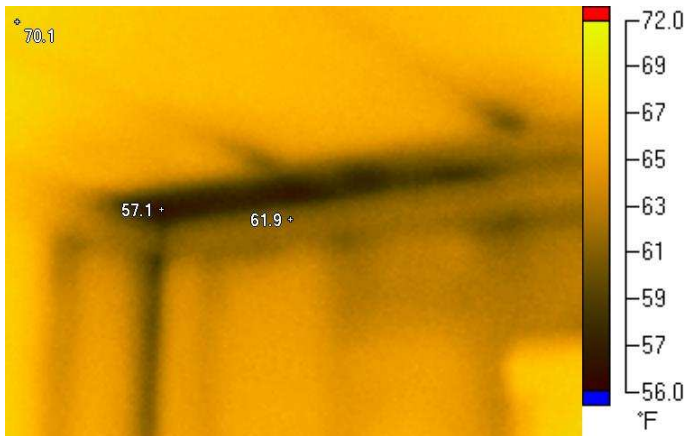
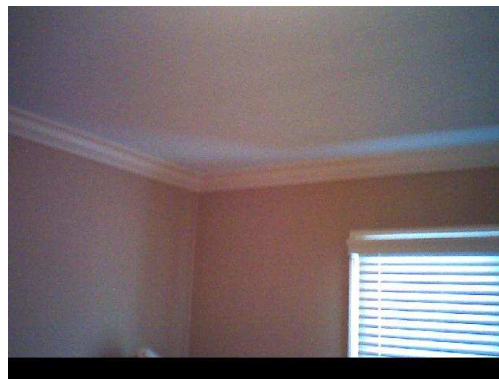
IR000604.IS2

Middle son room left ceiling above the window.

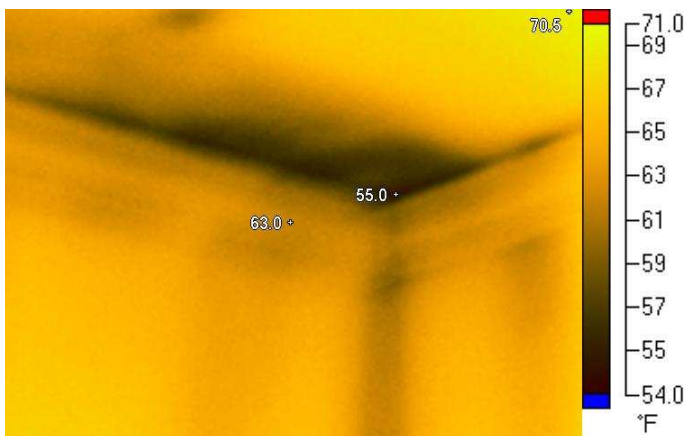
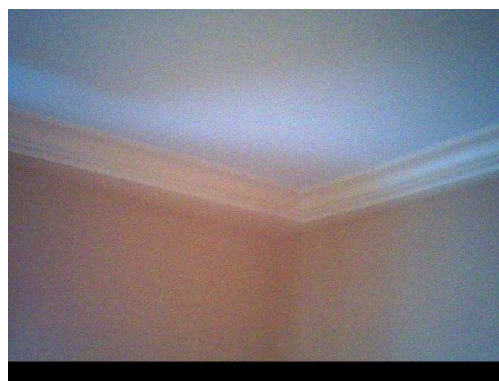
IR000605.IS2

Middle son room right ceiling above the window.

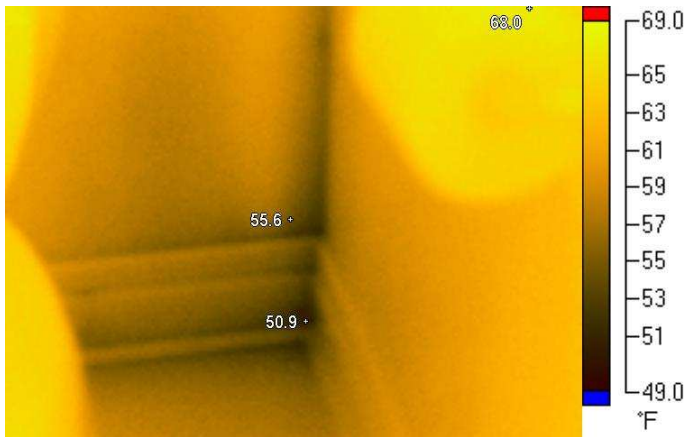
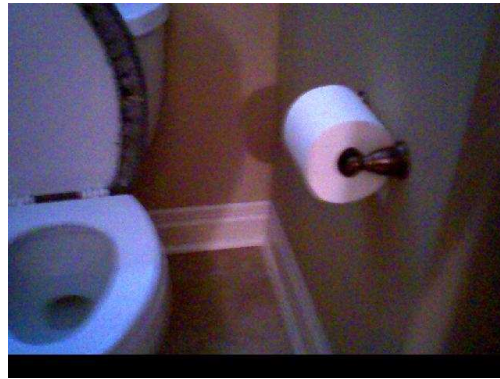
IR000606.IS2

Observed colder areas in the rooms directly over the garage. Due to ceramic tile on floor it is difficult to determine without destructive investigation if there is proper insulation and blocking in the floor under these rooms.

Middle son bathroom right side of toilet. This is over the garage.

Recommend evaluation of insulation in floor of conditioned living space that is over the garage. This may need to be an intrusive investigation.

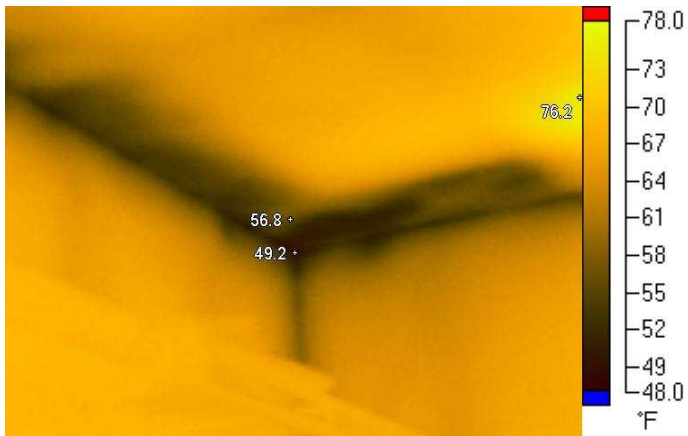
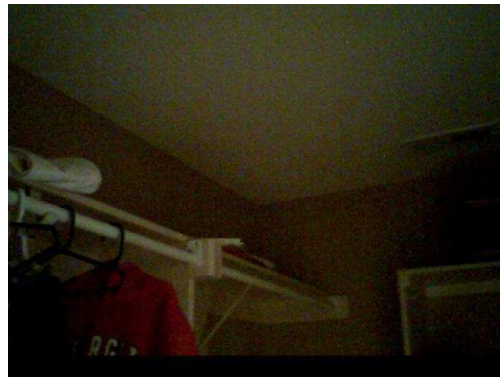
IR000607.IS2

Middle son closet left rear corner.

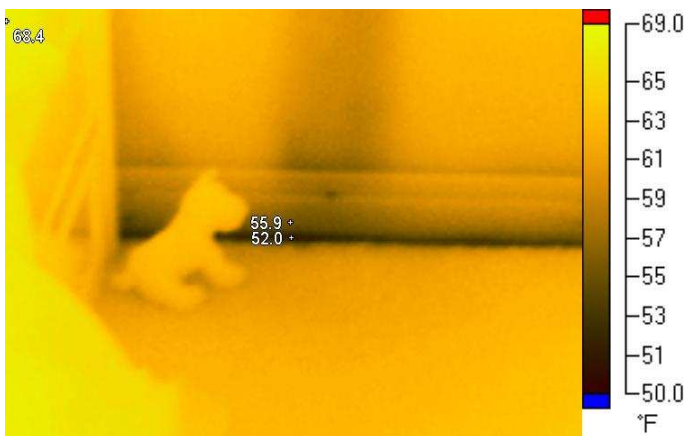
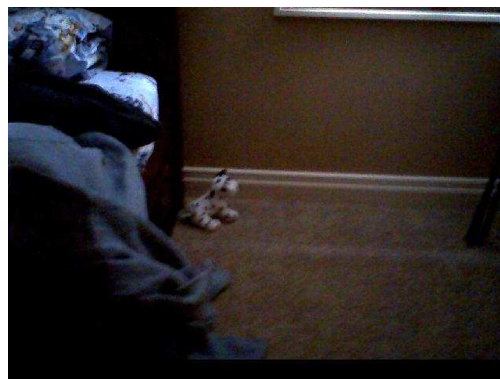
IR000608.IS2

Oldest son's bedroom right of bed at baseboard.

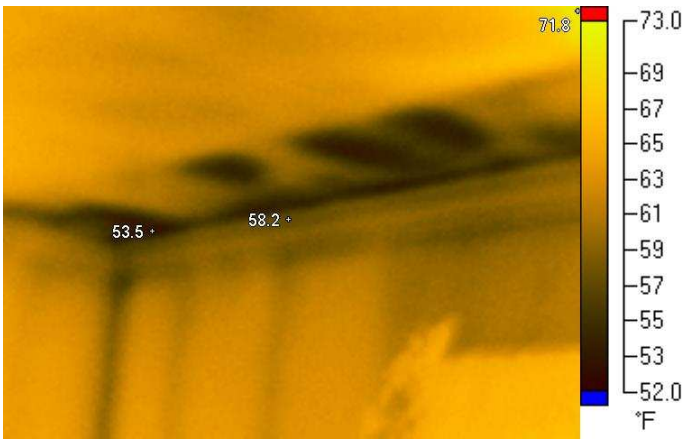
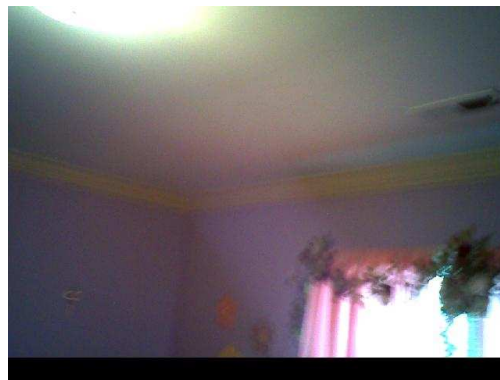
IR000609.IS2
1/27/2009 2:46:46 PM

Daughters room left rear corner ceiling.

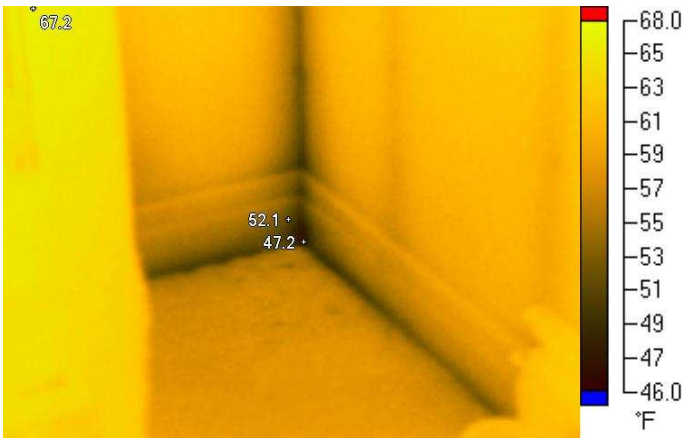
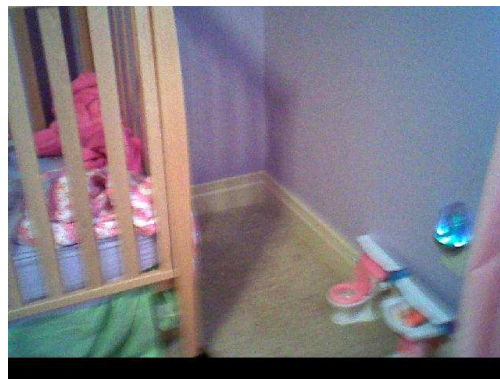
IR000610.IS2
1/27/2009 2:47:54 PM

Daughters room left rear corner baseboard.

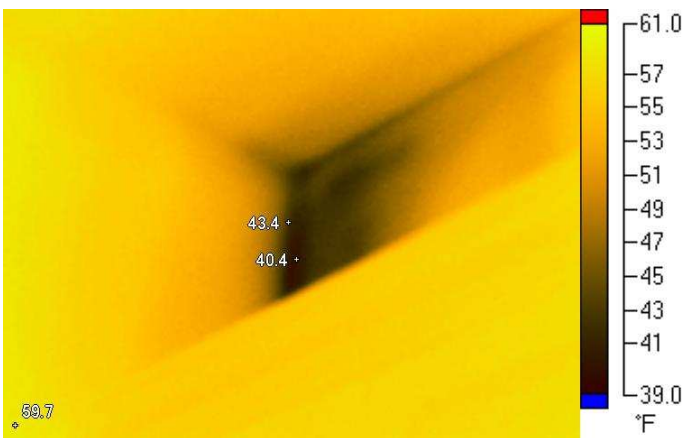
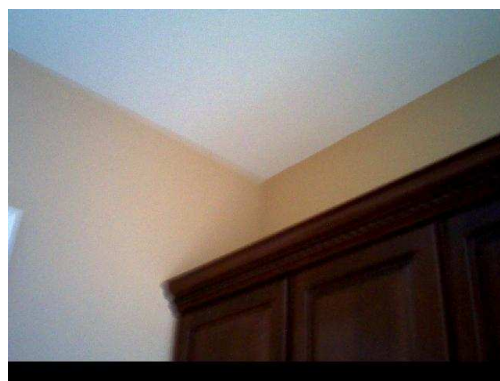
IR000611.IS2
1/27/2009 2:51:16 PM

Laundry room left wall. Exterior wall over cabinets. Angle is looking back at hallway entrance door. Coincides with dormer attached to house on exterior.

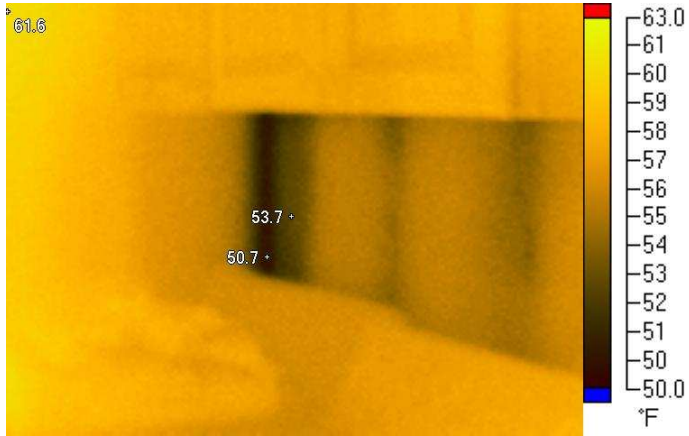
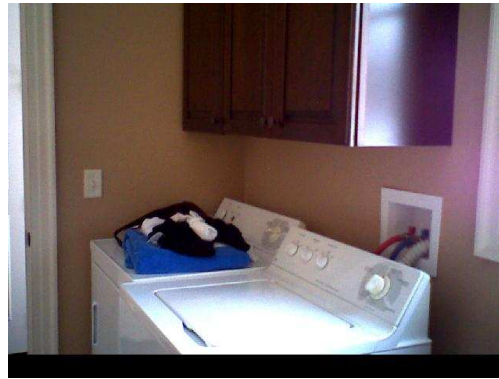
IR000612.IS2
1/27/2009 2:53:20 PM

Laundry room corner next to dryer.

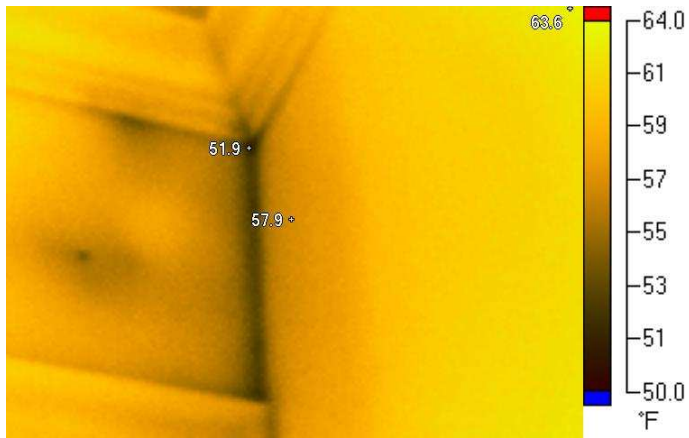
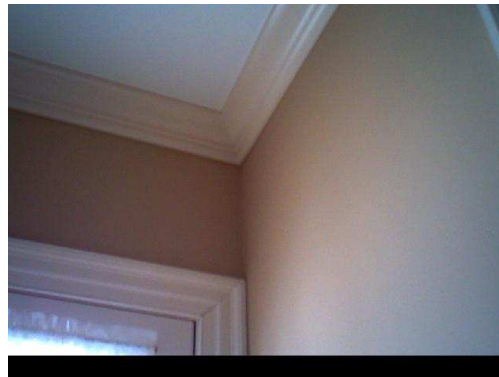
IR000613.IS2
1/27/2009 2:55:08 PM

Side entrance area at ceiling. Coincides with laundry room cool area.

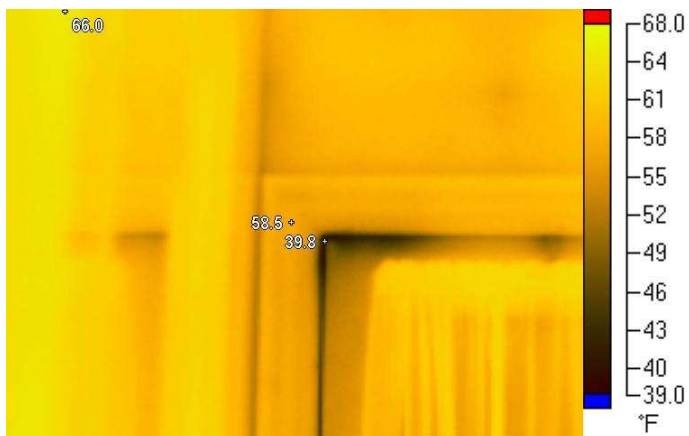
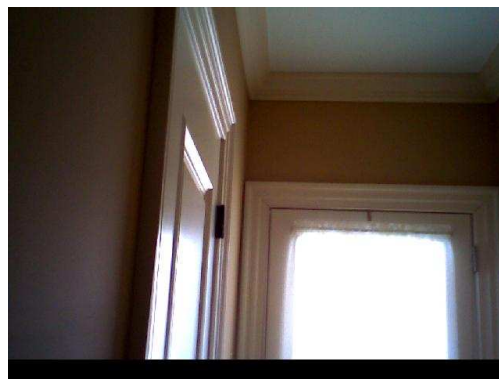
IR000614.IS2
1/27/2009 2:55:53 PM

Thermal imaging indicates cold air infiltration at side entrance door and visual inspection found weather stripping does not seal completely.

Side entrance door weather stripping gap.

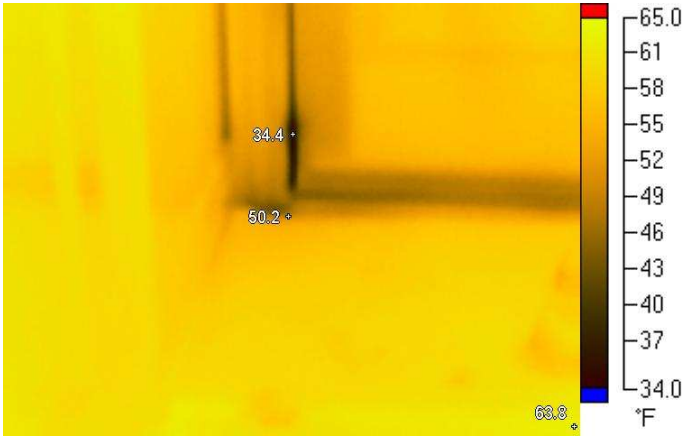
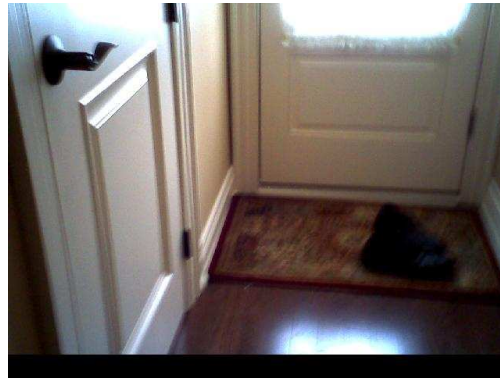
IR000615.IS2
1/27/2009 2:56:14 PM

Side entrance door weather stripping gap.

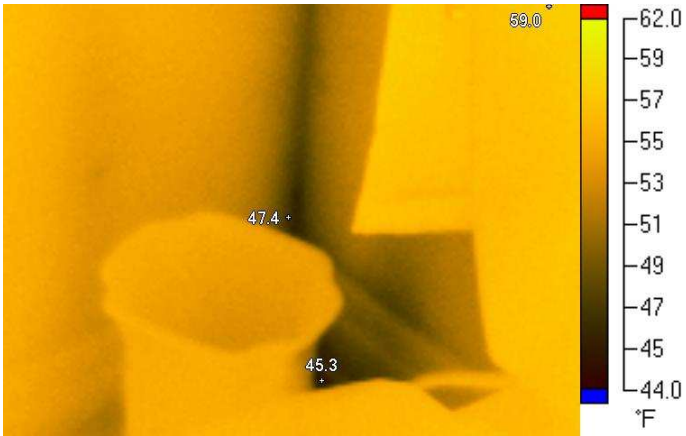
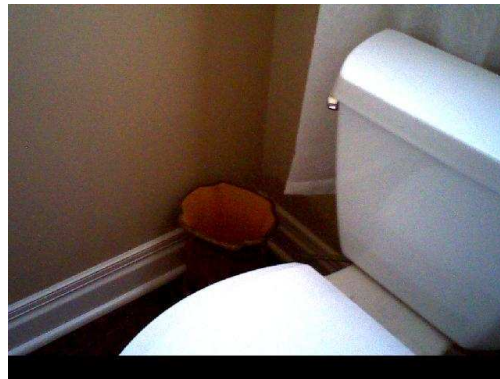
IR000616.IS2
1/27/2009 2:57:56 PM

Bath in side entrance hall way. Left of toilet at baseboard.

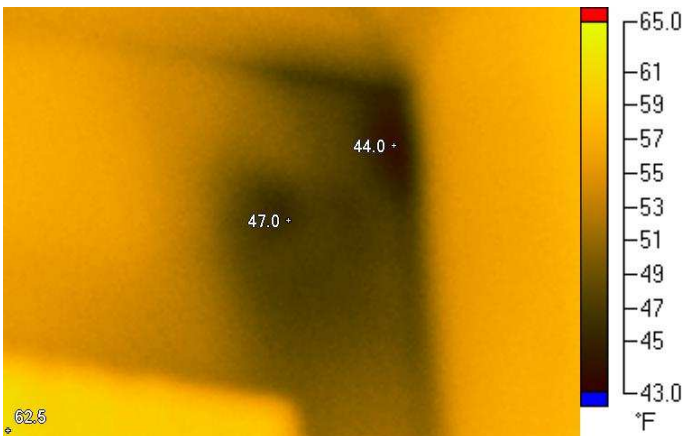
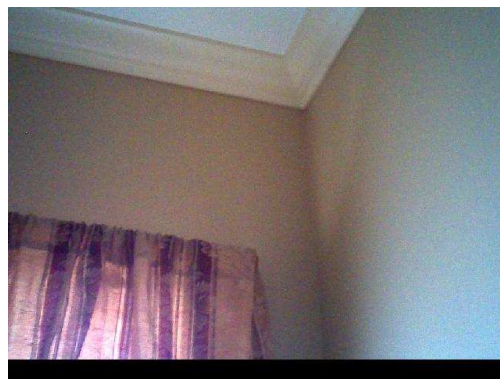
IR000617.IS2
1/27/2009 3:02:44 PM

Bath in side entrance way upper right wall on exterior wall. Coincides with dormer/porch cover on exterior.
